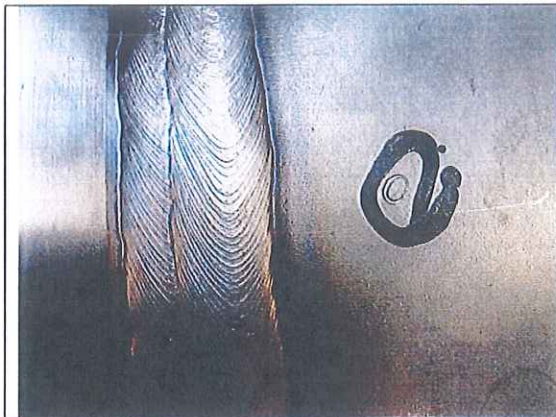
Nozzles during visual inspection – view of welder stamping and a typical weld

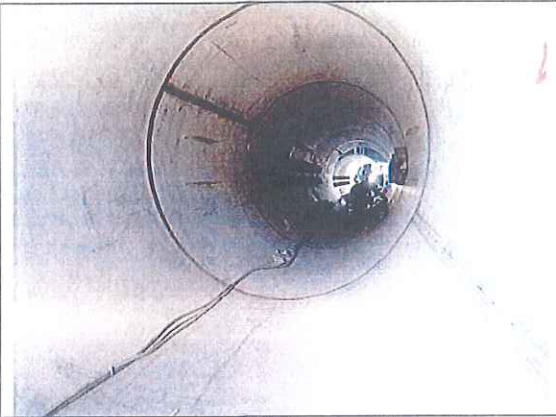
A view inside during the visual inspection

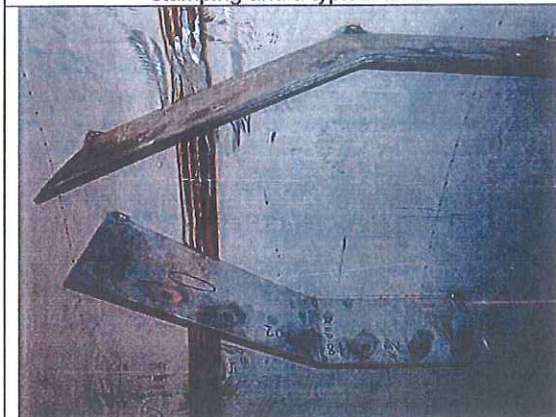
View of weld internals that were checked. The round seam these cross was not radiographed and although it was verified to be spot only if by repairs full RT was required this will be an issue.

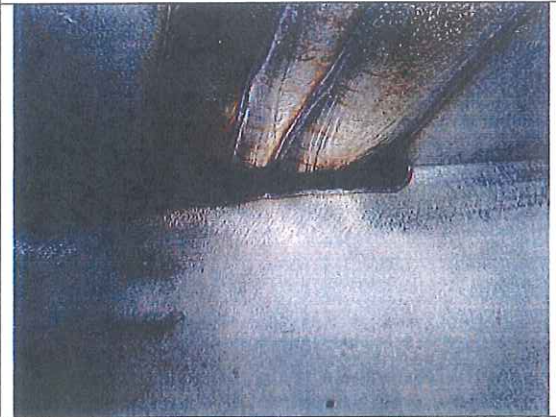
View of weld internals that were checked – close up of the issues mentioned left.

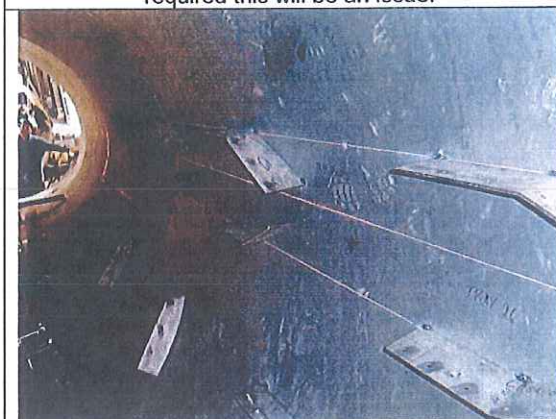
View of internals

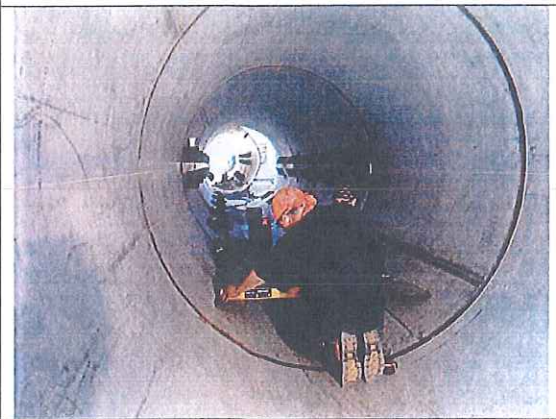
View of the fit up of internals in-process
