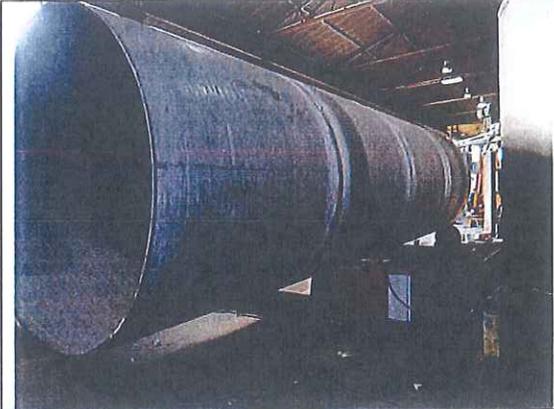
Overview of one section of the tower. Just on the edge of this picture was a carbon steel shell. This concern was discussed and they understood any contamination would need to be cleaned.

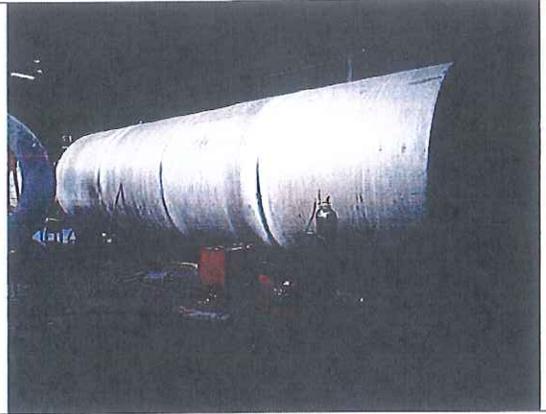
Overview of another section of the tower

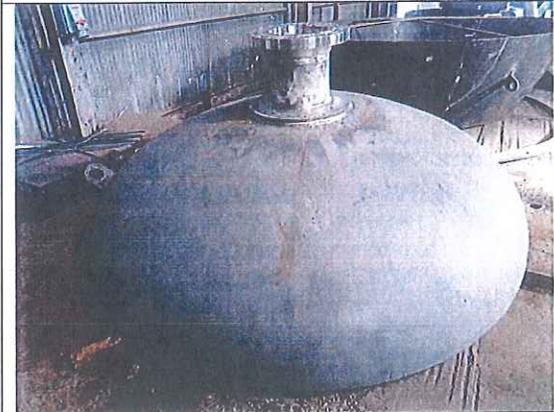
Overview of top head

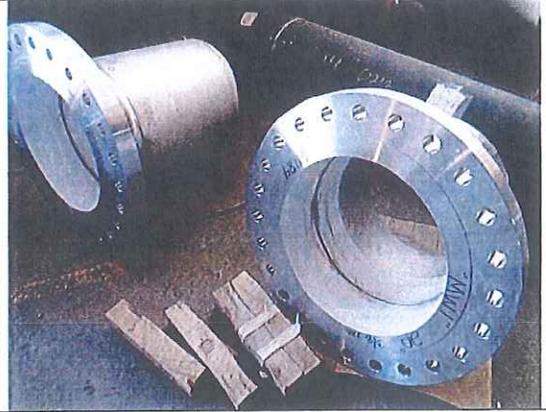
Nozzles during visual inspection- these are MW 1 and MW 2

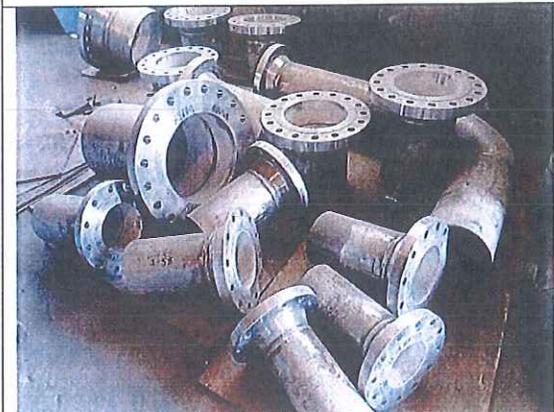
Nozzles during visual inspection

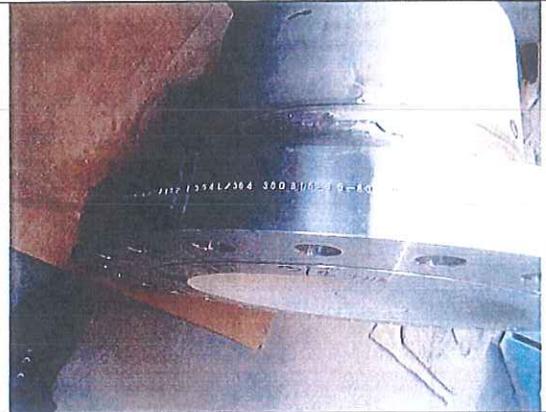
Nozzles during visual inspection – view of material stamping
