Year: 71
Date 6/8/11 3:15 PM

Ford Truck, SUV & Rear Wheel Drive Van : Bronco 4X4 : 1971

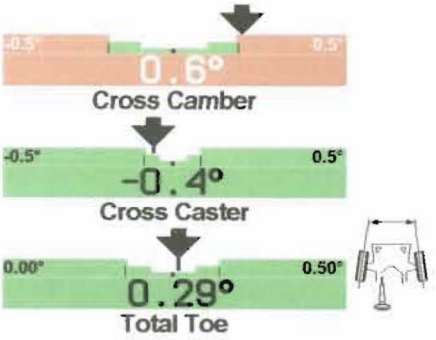
Current Measurements

- Excessive Camber could cause shoulder wear.
- Negative Camber could cause road shock or poor ride quality.
- Excessive cross Camber could cause a pull to the left.
- Individual toe can not be adjusted.
